RESULTS OF THE ACCESS EXPERIMENT

Walter L. Heard, Jr. and Judith J. Watson NASA Langley Research Center Hampton, Virginia 23665-5225

> Space Construction Conference NASA Langley Research Center Hampton, Virginia

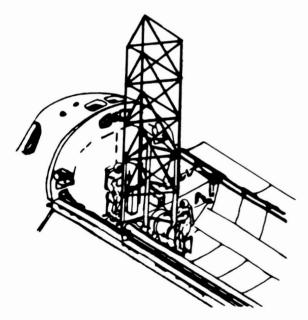
EVA-1: Nov. 29, 1985

Baseline experiment fixed foot-restraints

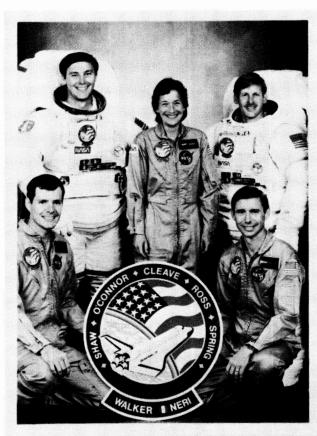
The five crew members responsible for the ACCESS experiment are shown in the photograph. They are Commander Brewster Shaw, Pilot Bryan O'Connor, and Mission Specialists Jerry Ross, Sherwood Spring, and Mary Cleave. In addition to performing their normal Shuttle mission activities, Shaw, O'Connor, and Cleave were responsible for monitoring the highly active EVAs, continuous video and photographic coverage of the experiment tasks, maintaining EVA procedures and timelines, and insuring crew safety. Ross and Spring performed the EVAs; Cleave operated the RMS during the expanded experiment activities. The figure shows the cargo bay configuration and the extreme forward location of the ACCESS payload.

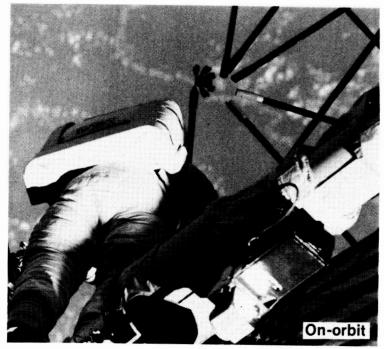
These photographs show the truss repair activity in neutral buoyancy (left) and on-orbit (right). In neutral buoyancy, a longeron, diagonal, and node were removed. On-orbit a longeron and node were removed from the seventh bay. (To remove one node, six struts had to be disconnected in this statically determinant truss). The strut and node were then replaced. The truss remained stable in the weightless environment with the struts disconnected and appeared to be unaffected by firings of the Orbiter attitude control system vernier thrusters. (Although likely, it has not yet been determined from the flight records if the vernier thrusters actually fired during this activity. However, the astronauts reported they never noticed vernier firings during either EVA days.)
